A Physical and Chemical Assessment of Presque Isle Bay Watershed Streams

**Report to the Erie County Conservation District
Waterford, Pennsylvania**

**Department of Environmental Science and Engineering
Gannon University
Erie, PA 16541**

June, 2002

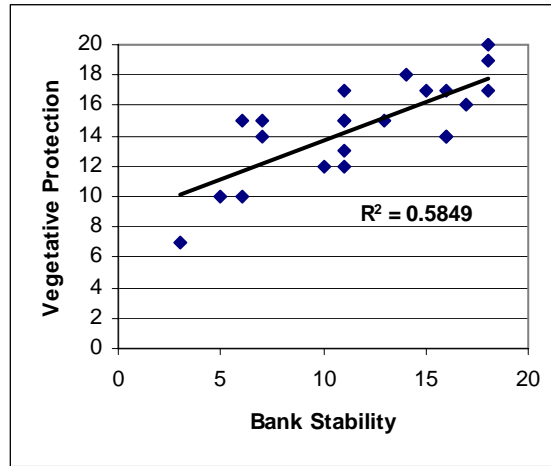
Figure 14. Relationship between the bank stability scores and the vegetative protection scores using combined right/left bank scores.

13b). The study sites showed similar results. Vegetative protection is a strong indicator of the stability of the stream banks. There appears to be a correlation between the bank stability scores and those for vegetative protection (Figure 14).

As indicated above, as the vegetative protection increases on the stream bank the bank tends to be more stable. This suggests that vegetation increases the stability of the bank by giving support through root systems and decreasing runoff and washouts.

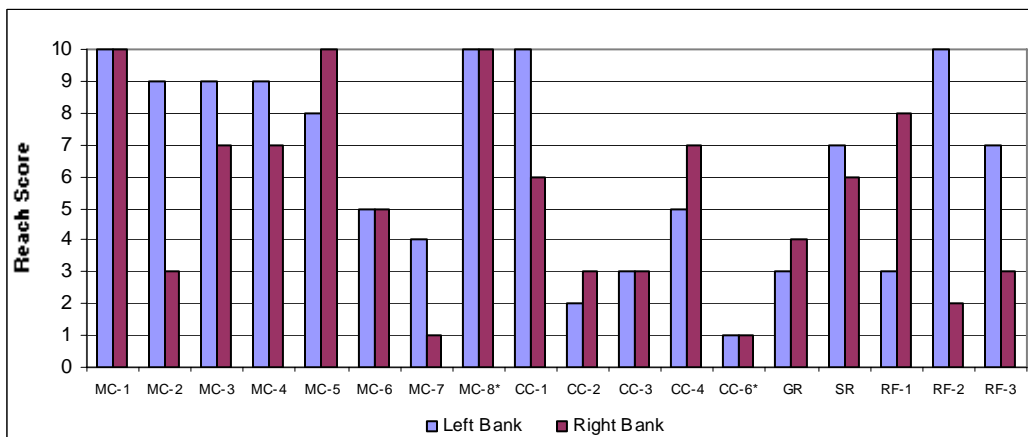
Figure 15. Riparian zone scores for all study sites.

Scores were assigned to sites based on the width of the riparian zone on each side of the stream (Figure 4.1-11). Natural riparian zones are essential to stream systems. Scores were determined based on the width of the riparian zone containing natural vegetation. “Optimal” scores are for zones above 18 meters, “sub-optimal”, 12-18, “marginal”, 6-12, and “poor” is less than six meters. Reference sites 1-3 had an

average combined score of 11, and reference sites 4-7 had an average of 10.5. Cascade Creek sites received lower scores overall than Mill Creek and Scott Run sites. Cascade Creek flows in a more urbanized and developed watershed. Garrison Run scored below the reference sites but was still in the marginal category.

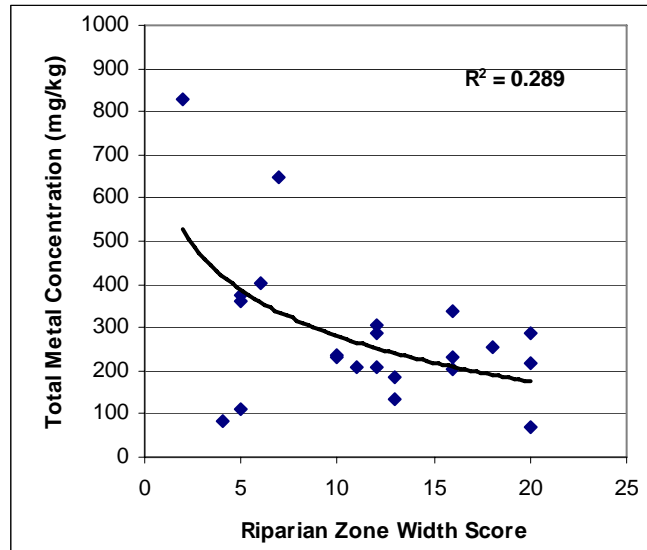
Figure 23. Relationship between total metal concentration and riparian zone width RBP score.

Mill Creek sites had similar concentrations overall as the reference sites. Reference sites 4-7 had an average total metal concentration of 94 mg/kg, lower than all study sites. A possible explanation for this is the rural area of the streams. These sites are far removed from any major roadways and other urbanization. The higher metal concentrations at the Cascade Creek sites may be linked to the characteristics of the watershed. The upper portion of the Mill Creek watershed, while somewhat urban is nonetheless relatively undeveloped and still retains a high portion of natural ground cover. Cascade Creek runs through a more industrialized urban area, with a high fraction of impervious cover, and a history of metal manufacturing, metal finishing, and metal plating industry. Also, Cascade Creek sites had less riparian zone than the Mill Creek sites. This may explain to some degree why it is more contaminated with heavy metals. It has been documented the riparian zones can protect the streams from urban runoff,

especially from roadways and in industrialized areas, which can contain heavy metals. While not statistically significant, the relationship between total metal concentration and riparian zone width (as reflected in the RBP score) suggests a trend (Figure 23). As shown in the figure, as the size of the riparian zone decreases, the more likely a site is to be contaminated with heavy metals. This suggests that urbanization, loss of vegetation, and loss of riparian buffers may be factors in the contamination of streams with heavy metals.
